Date: 27-Jun-2025

**Urgent Field Safety Notice**  
**3mensio Workstation (Vascular – Fenestrated)**  
**Version (10.6, 10.6 SP1, 10.6 SP2, 10.6 SP3, 10.6 SP4, 10.7, 10.7 SP1)**

The purpose of this letter is to advise you that Pie Medical Imaging is issuing an urgent Field Safety Notice regarding the clock position visualization in the fenestration diagram in 3mensio Workstation 10.6 (Vascular – Fenestrated layout) or 3mensio Workstation 10.7 (Vascular – Fenestrated layout).

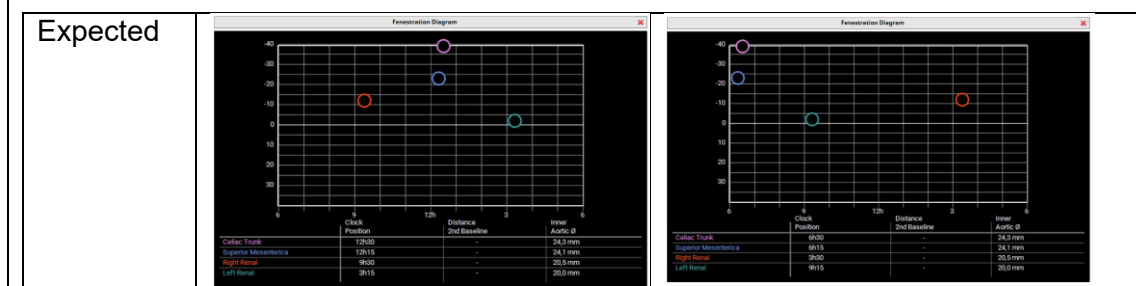
**Expected behaviour:** In the fenestration diagram all clock measurements should be updated relative to the new 12h position.

| | Fenestrated analysis with clock measurements started in 3mensio Workstation 10.6 (12h in AP direction) | Changing 12h position of a single clock measurement → results in an updated fenestration diagram with all clock measurements relative to this 12h |

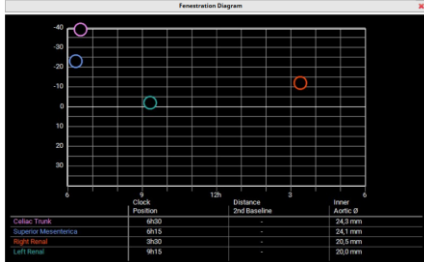
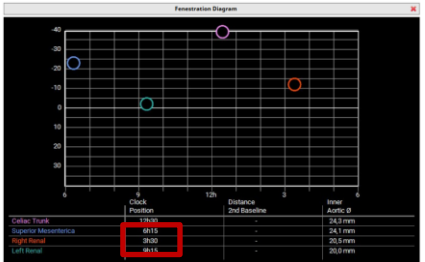
| Observed | | |

**Observed behaviour:** In the fenestration diagram only the adjusted clock measurement is updated to the new 12h position. The other clock measurements are not updated relative to the new 12h position

| | Opening a fenestrated analysis with clock measurements | Changing 12h position of a single clock measurement → Only the adjusted clock measurements is updated in the fenestration diagram. |

**Impact:** The hazard exists that the clock positions are not correct in the report causing fenestrations on a stent graft at an incorrect position. This could potentially be harmful for the patient since this could potentially lead to permanent tissue damage. If FSN advice is followed there is no residual risk.

In case you open a session state with saved clock measurements created in **3mensio Workstation 10.6** and there is a need to adjust the **12h position** for the clock positions, make sure to update **all** individual clock measurements in the perpendicular plane by the following steps:

1. Click on the clock position.
2. Update the 12h pointer of the clock in the perpendicular viewport.
3. Perform step 1 & 2 for all clock measurements in the analysis.

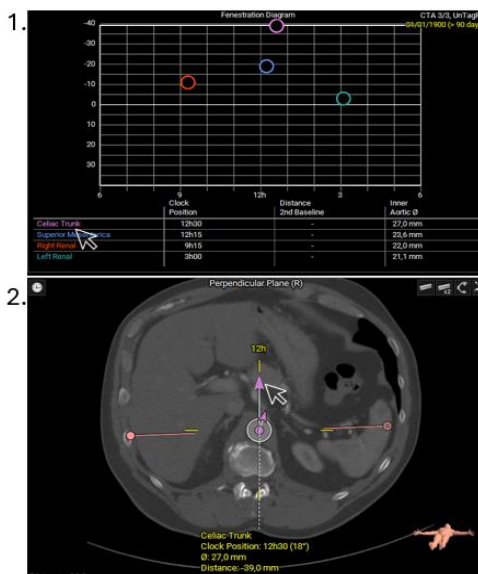
After updating all 12h pointers, the information shown in the fenestration diagram is correct and functionality is restored.
