**FSN Ref:** 2025-FSN-000103

**URGENT Field Safety Notice**  
**Risk of Automated Impella Controller (AIC) Intermittent Impella**  
**Detection Issue.**

| 1. Information on Affected Devices* | |
|---|---|
| | All Automated Impella Controller (AIC) |

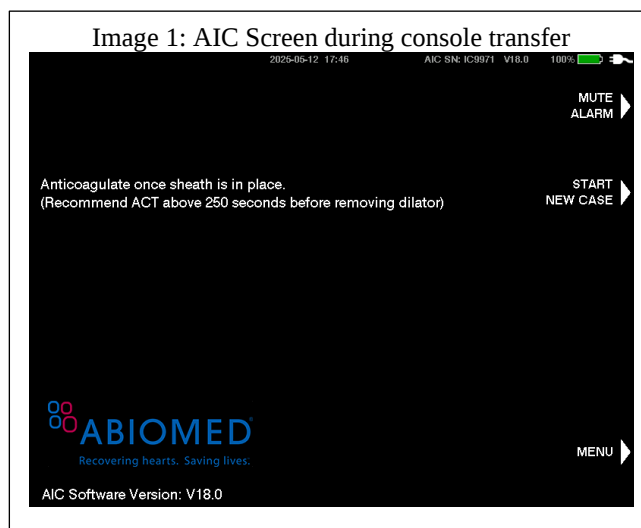
During console-to-console transfer, if the pump is not detected once connected to the AIC, the AIC screen in Image 1 remains and does not advance.

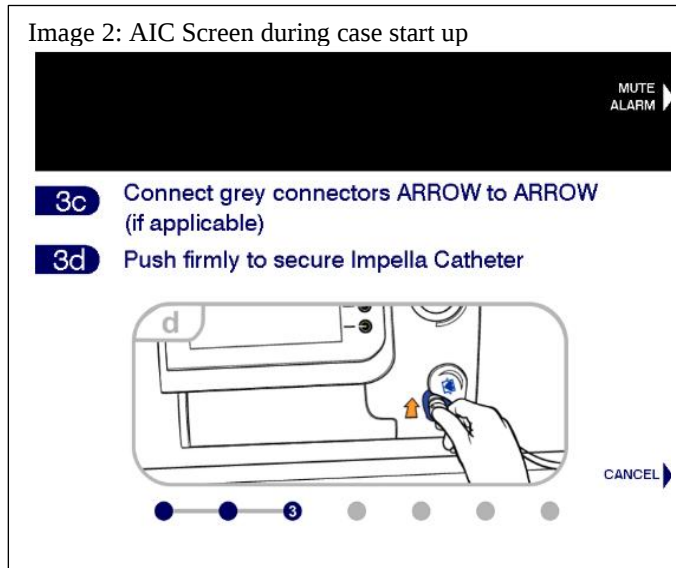
During case start, if the pump is not detected once connected to the AIC, the AIC screen in Image 2 remains and does not advance.

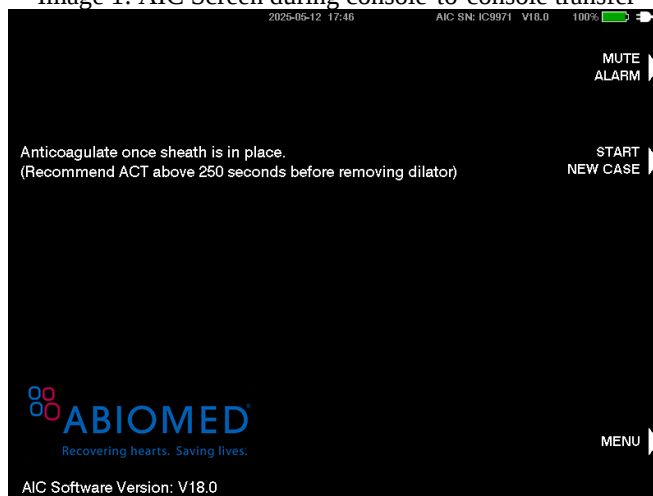
Image 1: AIC Screen during console-to-console transfer

The AIC screen in Image 1 remains for more than 20 seconds and does not advance after connecting the pump to the receiving console:

- Scenario 1: If no alarm on the previous console, then immediately switch the pump to the previous console to restore support to the patient.
- Scenario 2: If the previous console displays an alarm message, then switch to a different console if available. If a different console is not available proceed to scenario 3.
- Scenario 3: If the previous console displays an alarm message, but a different console is not available, then re-start the case on the receiving console (console that does not advance from Image 1 before attempting to re-connect a pump):
  1. unplug the pump
  2. re-start the console
  3. press START NEW CASE from the startup screen

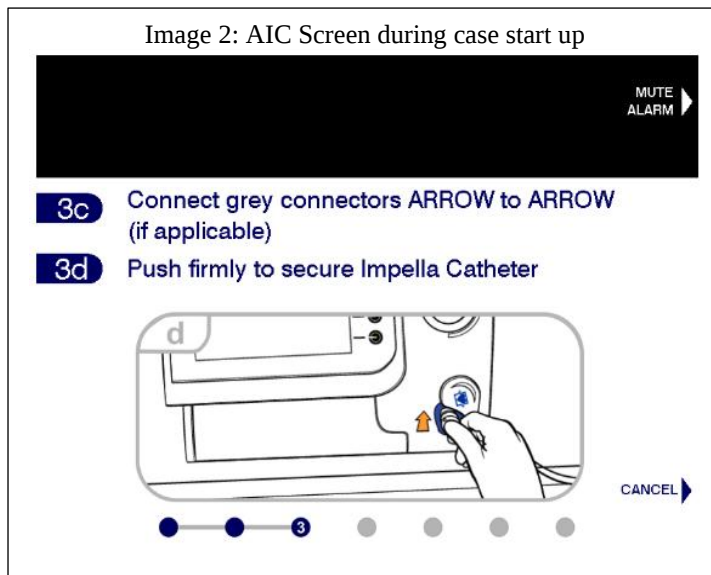
The AIC screen in Image 2 remains for more than 20 seconds after connecting the pump and does not progress to indicate “Detecting Impella”:

- Option 1: re-start the case:
  - unplug the pump
  - re-start the console
  - press START NEW CASE from the startup screen
- Option 2: switch the pump to a different console if available.
