FSN Ref: 2025-FSN-000103

Date: 2025-06-24

URGENT Field Safety Notice
Risk of Automated Impella Controller (AIC) not detecting an Impella pump when it is connected.

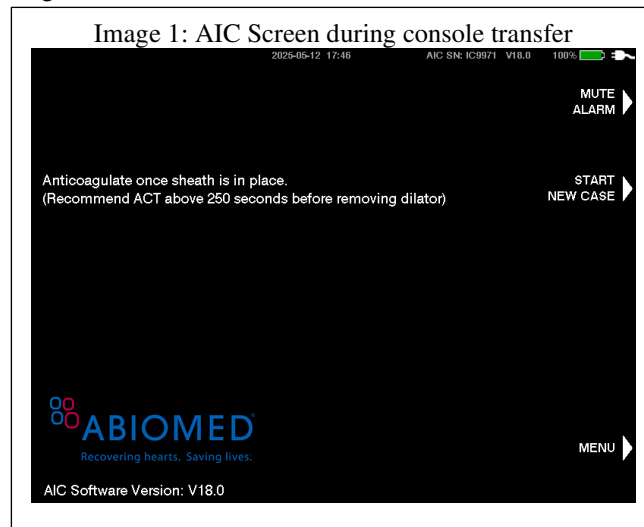
During console-to-console transfer, if the pump is not detected once connected to the AIC, the AIC screen in Image 1 remains and does not advance.

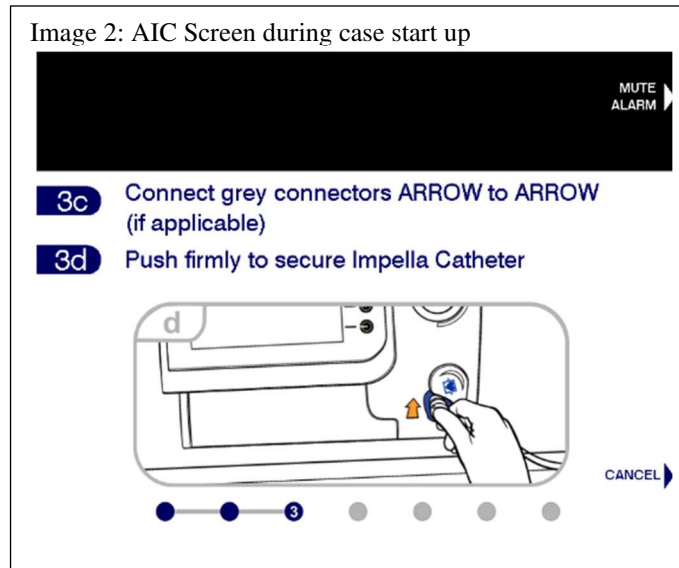
During case start, if the pump is not detected once connected to the AIC, the AIC screen in Image 2 remains and does not advance.

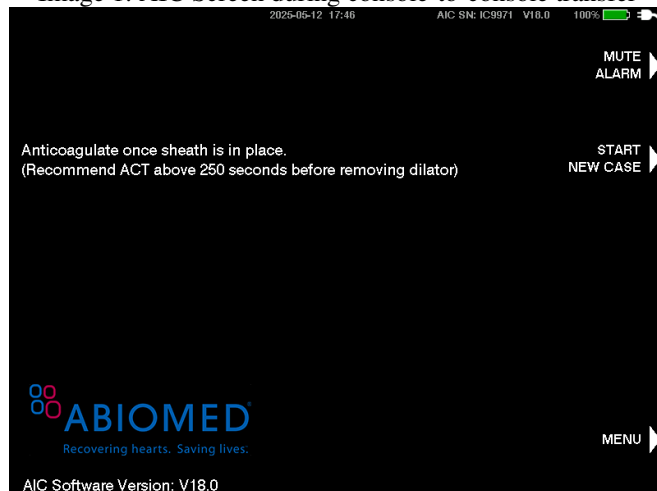
Image 1: AIC Screen during console-to-console transfer

If the AIC screen in Image 1 remains for more than 20 seconds and does not advance after connecting the pump to the transferred console:

- Immediately switch the pump to the previous console to restore support to the patient.
- If the previous console displays an alarm message, switch to a different console if available.
- Restart the console that does not advance from Image 1 before attempting to re-connect a pump.
