## FIELD SAFETY NOTICE

### Missing plug

**Macopharma Reference Number:** DEV-2025-00070

Macopharma is issuing this letter to inform you of a potential issue with the non-leukoreduced red blood cell collection bag (CV1459) on its inline filtration systems. The affected references and lots are listed in this FSN.

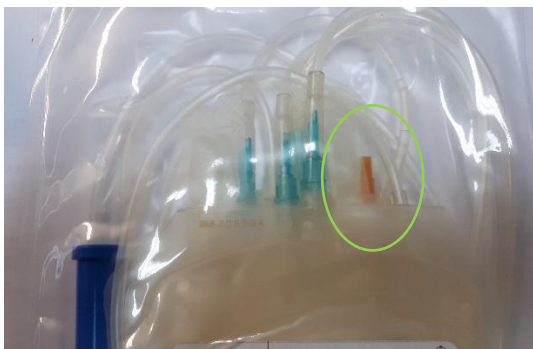
**WITH PLUG ON THE BAG**

*Picture taken of the device in the overwrap*

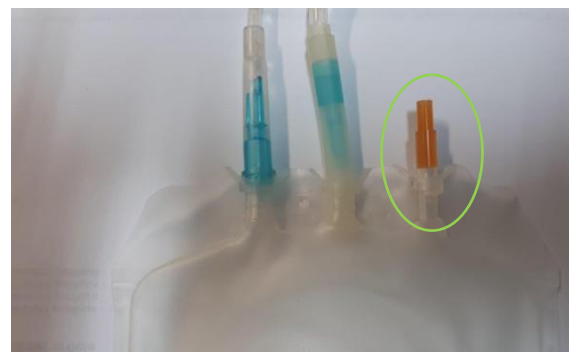
*Picture of the bag CV1459 with plug*

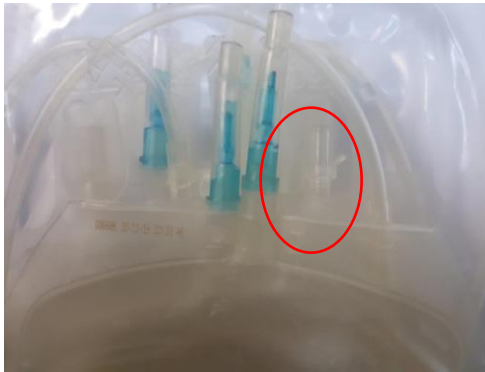
These missing plugs cause a leak detected during the separation of blood components on the press.

This defect is due to a sporadic human error during the device assembly step. An investigation has been launched to implement the necessary corrective and preventive actions in the production plant concerned.

WITHOUT PLUG (NON-COMPLIANT PRODUCT)

*Picture taken of the device in the overwrap*

- Before opening or when opening the peelable pouch, check for the presence of the (orange) plug on the red blood cell collection bag for non-leukoreduced blood (see photo above).

- Check for the presence of the (orange) plug on the red blood cell collection bag for non-leukoreduced blood before separating blood components on the press.

If the plug is missing, please send the kit to your Materiovigilance Dpt.

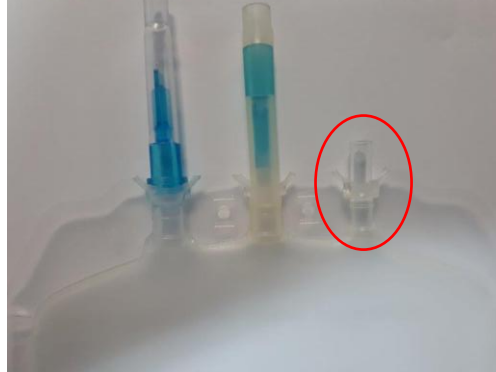
*Picture of the bag CV1459 without plug*

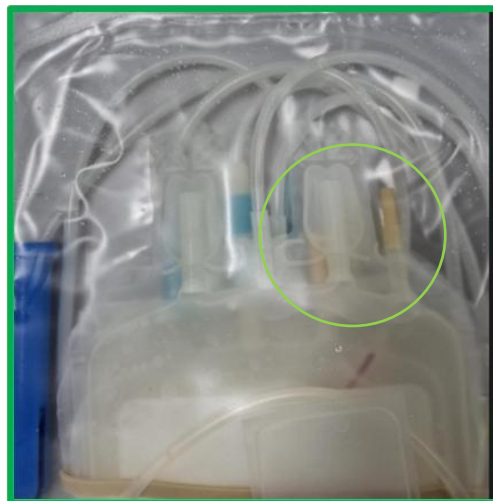
*Picture taken of the device in the overwrap with two visible plugs: one on the empty bag and one on the bag with the additive solution.*

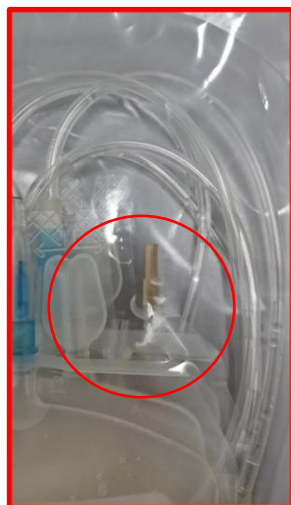
*Picture taken of the device in the overwrap with only ONE visible plug.*
