## Field Safety Notice

FA 2021-05-002-LUL-003

OctoStretch™ with Stretch Leveler, FlexoStretch™, Stretch Leveler, LikoStretch™ 1900, LikoStretch™ Mod 600 IC.

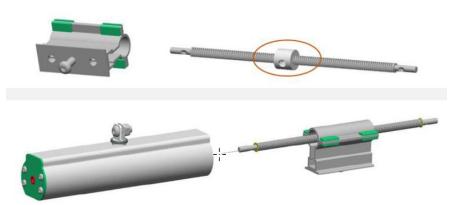
Figure 2

The function of the Stretch Leveler connected to the OctoStretch is to allow for adjustment of the center of gravity during lift. The Stretch Leveler is composed of a trapezoidal nut attached to an attachment profile on a threaded rod. If the trapezoidal nut breaks the leveler can shift center of gravity without the user activating the function, causing the stretcher to tilt unexpectedly. See Figure 2: Main components and assembly of Stretch Leveler. Trapezoidal nut circled.

Hillrom is replacing the stretch leveler to mitigate this risk of breakage. Upon completion of the enhancement(s), Hillrom will contact customers to coordinate update of the leveler device.
