Tracoe Reference: FSCA 2026-09

## Field Safety Notification

### **Urgent Field Safety Notice regarding updated instructions for use for Tracoe Vario P Tracheostomy Tube and Tracoe Experc Set Vario**

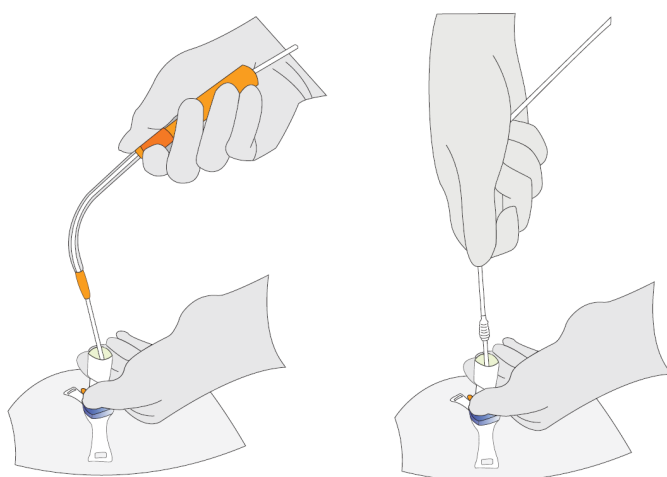
**Pic. Correct removal of the inserter before separately removing the guiding catheter for Tracoe Vario P-tube**

- Apply a pea-sized amount of the enclosed **lubricating gel** on the tip of the insertion system and the tracheostomy tube.
- Do not pull on the guiding catheter separately while the inserter is still inside the tube.
- Do not kink the tube when removing the inserter or the guiding catheter
- **Proceed step by step:**
  - **Pull out the orange inserter - without the guiding catheter**
  - **Pull out the guiding catheter separately after the removal of the inserter**
- Ensure that the silicone sleeve is still on the guiding catheter when the guiding catheter is pulled out.
